Project Name:	Mountain Valley Pipeline	Inspector:	Matthew Grant
Inspection Date:	Thursday, February 25, 2021	Project Contact:	Brian Clauto
Spread H: Franklin	ST13198-13262+62 ATWS 1055 AR-FR293.01	Weather:	Dry

FIELD INSPECTION PHOTO LOG

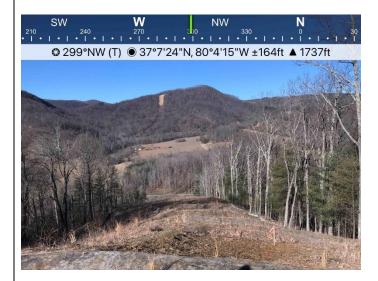
Figure 1: St13207+00 ECD's are in place and functioning.

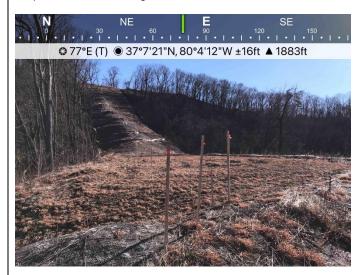
<u>Figure 2</u>: St 13210+80 Permanent style water bars are in place and functioning.

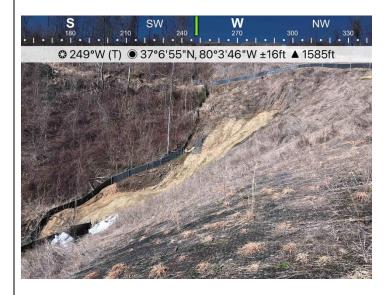
<u>Figure 3</u>: Blanket matting has been installed on slip area near St13250.

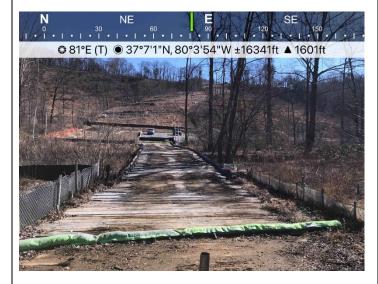
3. Area	s of offsite	sediment deposition	observed	?				\boxtimes	
 <u>Comments:</u> Inspected the following resources: S-II4 ECD's were in place and functioning at the designated crossing. 									
Routine Maintenance: (<u>72-Hour Deadline</u> from Notification) - N/A									
Ineffective Controls: (<u>24-Hour Deadline</u> from Notification) - N/A									
Recommended Corrective Action: N/A

Figure 4: Designated crossing S-II4, ECD's are in place and functioning.
